# Series of example flight deck photos

# USS Bonhomme Richard, prior to blasting

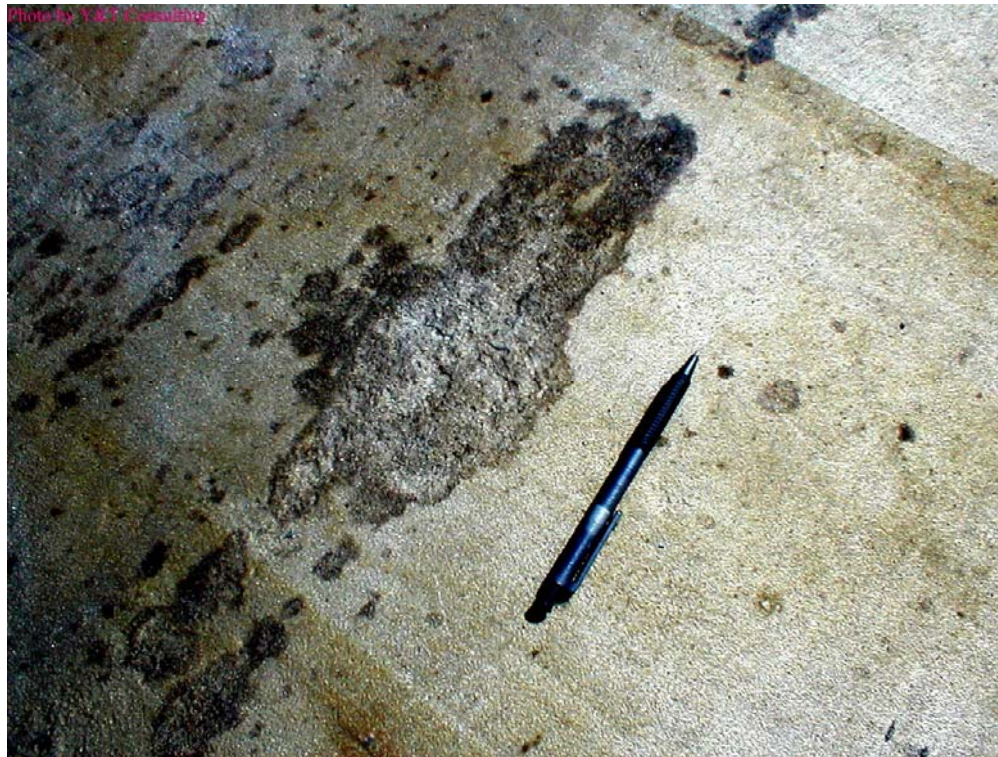
Light flash rust; dark stain from prior damage  
YK Consulting, Troy Brill, USS Lake Champlain, light  
flash rust

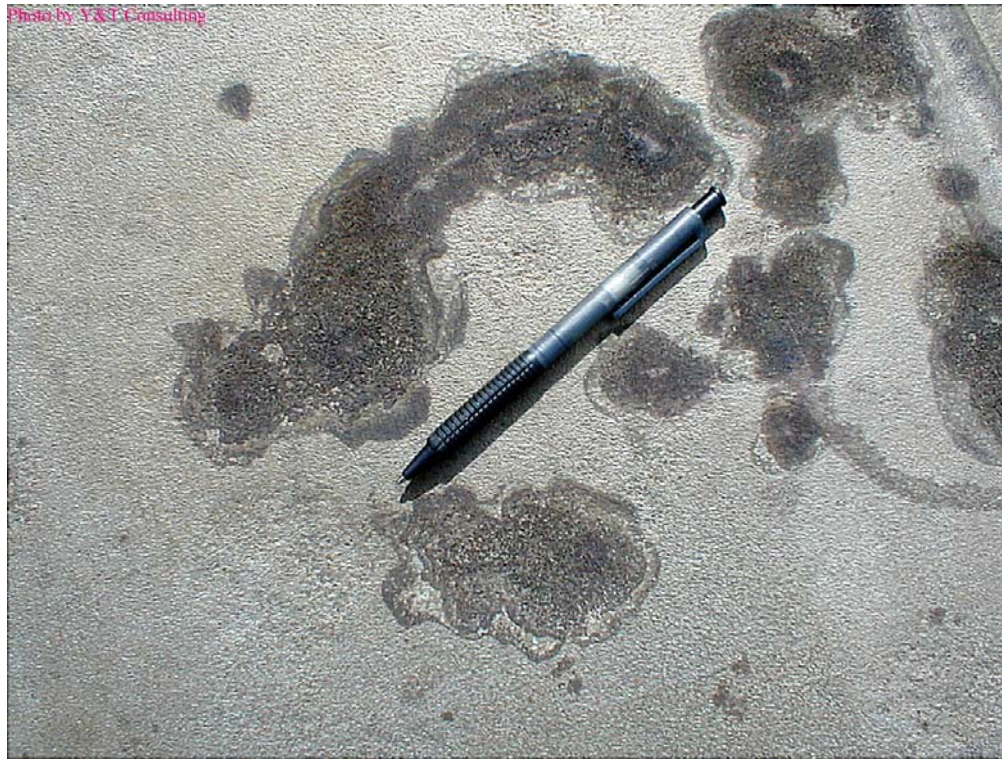
This is example of the dark stains which cannot be removed by UHP WJ except by repeated cleanings. There is no visible thickness. It is an inert iron oxide (as the pigment in paint). International Paint in their Hydroblast Standards refer to this condition. In the WJ Standards the wording is: "The gray to brown-black discoloration remaining on corroded and pitted carbon steel that cannot be removed by further waterjet cleaning is not considered part of the percentage staining."

USS Lake Champlain, by Y&T Consulting, Troy Brill, dark stain, very light flash rust
