MATERIALS ENGINEERING LABORATORY

ANALYTICAL REPORT

REPORT NO.: FA-0079-00

SAMPLE IDENTIFICATION: Coating System, Non-Skid (MIL-C-24667A)

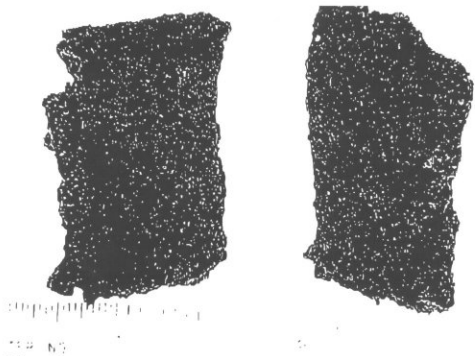
The loose section of non-skid coating was examined with the stereo light microscope. As shown in Figures 1 and 2 of Enclosure (1), red and black corrosion products were present on the underside of the sample.

Figure 1. Sections of non-skid coat removed from flight deck. Underside surface shown with obvious corrosion products visible (scale shown).

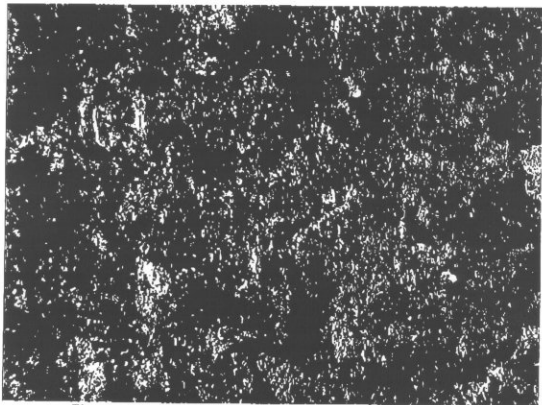
Figure 2. Magnified (approximately 20x) view of above sample.
